What Happened?

During unrelated excavations of the Waipori 2 switchyard it was discovered that joints in earth bonding were severely corroded.

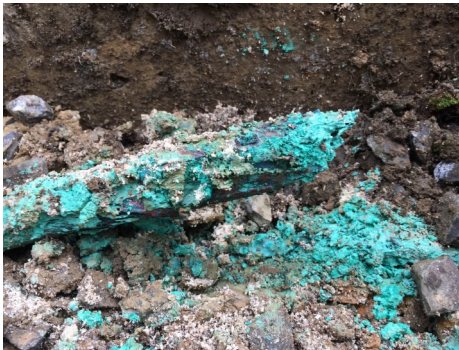
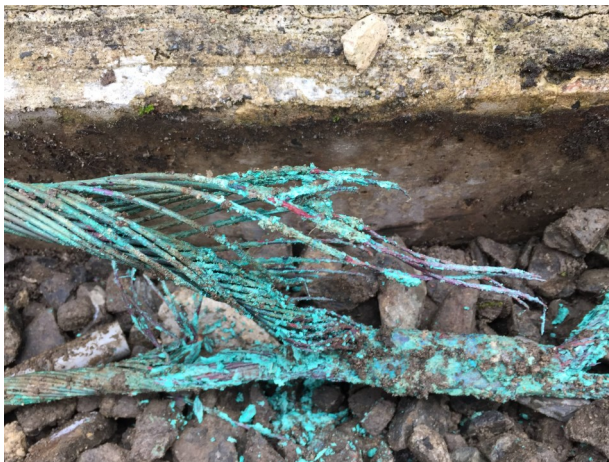
None immediately. Would drastically reduce the current carrying capacity during a ground fault. Possibly resulting in a failure to trip.

Historic salting of test points and type of flux used for “Henley” crimp joints.

Example of a corroded joint

- Electrical tests completed in 2016 and 2010 showed no obvious issues.
- Scope for repairs to be carried out in the new year underway.
