SAFETY ALERT

Mt Millar Lift Near Miss

14 September 2018

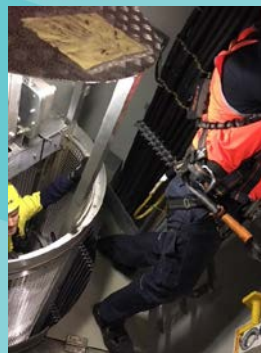
There are no barriers and space is limited around the lift well on the upper lift landing platform. There are known hazards of entanglement and exposure to an unguarded edge. The existing control, which was not completed on this day, was for those at the top and bottom of the tower to communicate before driving the lift down from the 'operator station controls' to ensure that everyone has ascended clear of the moving lift.

Entanglement Hazard

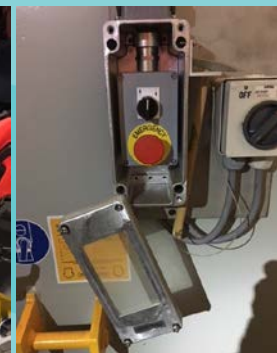
During the investigation it was discovered that the 'operator station controls' at the lower lift landing platform were in fact emergency controls and not intended for general use. The glass covers had been bypassed as per the photo. It is believed that all covers were originally removed around 2007 shortly after commissioning to increase the efficiency of transporting personnel due to the inherent limitations of the original lift design. This practice has then been inherited by new personnel over the years and become standard procedure.

The adoption of and continued use of operating the lifts via the emergency controls resulted in a situation that was not error-tolerant. If the lift was operated in accordance with the operating manual and within its original design limitations, this event would not have occurred.

Bypassed emergency controls

- Reinstallation of the glass panels on the emergency controls to ensure the lifts are only driven by those inside as per the operating manual;
- Cease use of emergency door release keys to access intermediate platforms;
- A full review of the lift design to determine possible engineering improvements;
- Review of safety signage within the lifts and other relevant locations;
- Contacting the lift and turbine manufacturers to obtain any updated operating manuals and training procedures;
- Development of a formalised lift training framework;
- Working with the independent inspectors to improve their inspection criteria; and
- Updating the daily lift inspection checklist.
