SAFETY ALERT

Shared Learning's

Live Stator Heater Chassis

29th October 2018, 11.30am

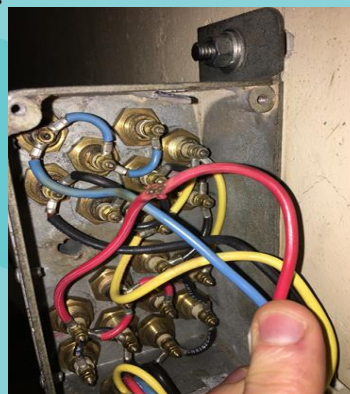
PHOTO:

On inspection it was found that the red phase conductor had been in contact with the metallic chassis of the heater. It appeared that the conductor had chafed on the rivet holding the metallic chassis in place allowing the contact to take place.

Additional it was found that the heater chassis was not earthed.

At some point in the past, the heater chassis would have been live at 230V AC and this could have provided an electric shock to someone who touched the heater chassis.

On further investigation it was confirmed that there was no earth on the chassis of the Generator heater. Only the steel armouring of the cables (via many separate joins) would have provided a poor quality earth connection, this is non-compliant and not safe as it does not guarantee the correct operation of the electrical protection.

At the next available opportunity, the heaters in the remaining unit stators should be inspected by an electrician and where necessary the heater chassis will be bonded to the station earth.

If persons are removing the stator covers on other units before the heaters have been inspected and earth, the heaters should be isolated as the point of supply prior to the work.
