## CONFIRMING ISOLATIONS & VALVE INDICATION STATUS ARE CORRECT

21 Jan 2019, Maraetai Hydro Power station.

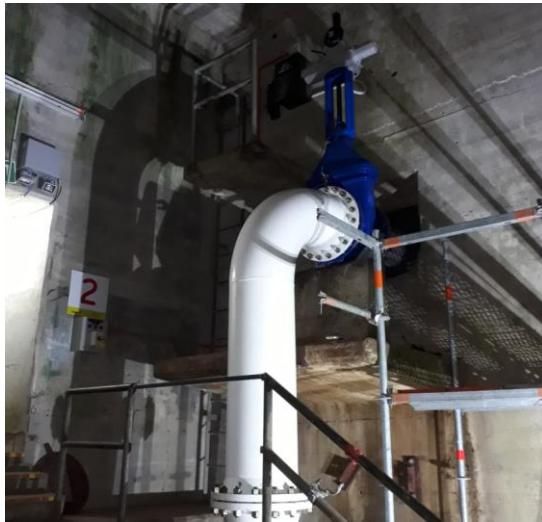
When isolating the G2 penstock priming valve as per an operating order, the operator failed to confirm the valve was fully closed, instead he relied on the recipient's interpretation of the valve position which was incorrect.

The valve was electrically isolated in a 2/3<sup>rd</sup> open position when it should have been fully closed. This resulted in priming of the penstock when water was introduced into the priming bus during operations later that day.

Significant contributing factors were the lack of lighting, access and poor valve position indication, making it difficult to ascertain if it was open or closed.

- Anyone applying isolations (IASM / RASM) are to physically check the status of the equipment prior to applying the lock and tag
- The recipient shall, before the permit is accepted, ensure, as far as practicable, that all required issuer applied safety measures have been applied.

- They familiarise themselves with the type of valve being worked on, and its method of position indication prior to operation
- Where valves can be operated remotely, adequate position indication is installed at the point where the valve is controlled or operated
- That they have good lighting (either portable or fixed) to be able to identify the valve position.
- Where practicable, there is a mechanical valve position indicator installed so that the position of the valve can be easily identified.
