# Safety Alert

**INCIDENT TITLE:** Fall from Height due to Barrier Failure

**TIME AND DATE OF INCIDENT:** 24<sup>th</sup> July 2019

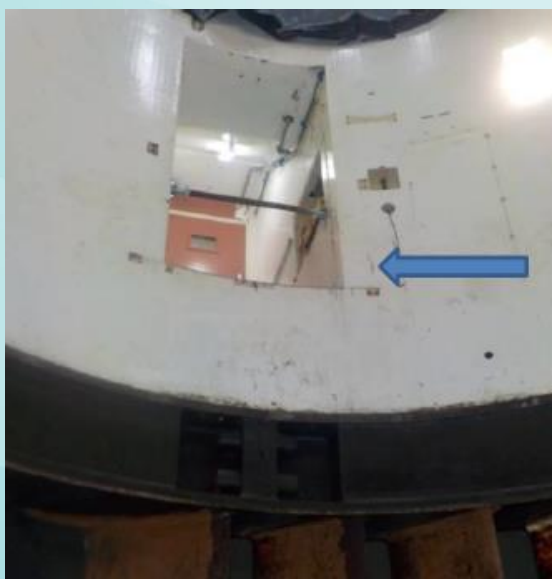
## PHOTOGRAPHS

Temporary barrier rails had been put in place at the edge of the direct drop into the pit area.

When weight was placed against the lower rail to retrieve an item from below, it gave way resulting in the contractor falling into the pit and fracturing his leg.

The suitability of the choice of barrier and the manner of installation have been identified as contributing factors to the fall.

Despite the need for a control being identified, the barrier chosen was not suitable and all forms of fall protection/restraint should be load bearing and not acting as a visual barrier only.

Any barrier used as a form of fall protection or restraint should be fit for purpose and adequate risk assessment carried out to ensure the control put in place is sufficient.

All site managers to ensure barriers to any open areas where a fall could occur are fit for purpose and correctly installed.
