# SAFETY ALERT

## Shared Learnings

Electric Vehicle Unexpectedly Braking

14 August 2019, 8.00am

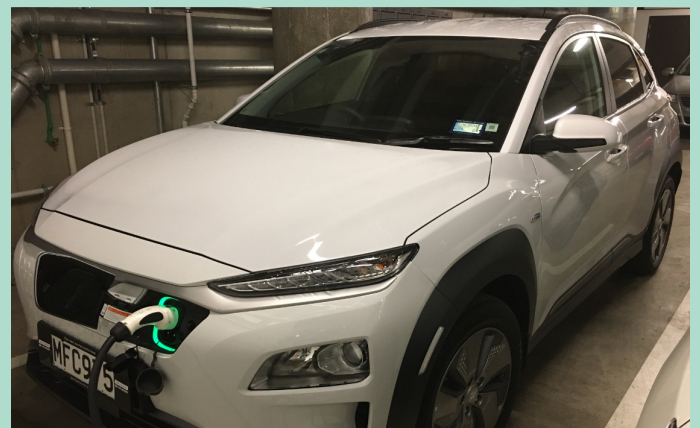
### PHOTO:

A Hyundai Kona EV was on cruise control set at 50kph travelling through a 50kph residential area.

At the time of the incident, there were no other vehicles in sight in front of the vehicle. Suddenly, the car braked heavily without warning and with no obvious hazards to trigger the sensors.

Extensive testing was performed on the vehicle and it was concluded that the event occurred due to a sensor fault. The sensors were re-set and the vehicle underwent rigorous testing over several days in different conditions to re-enact the fault. The fault has not since re-occurred, and Hyundai is confident the issue is resolved. The vehicle will be put back into the pool service.

The vehicles also need to be car washed after every long distance or non-sealed road trip, so the sensors are kept clean of dirt and build up, which can be a contributing factor to events of this nature.
