# Safety Alert

**INCIDENT TITLE:** Coffee Machine Socket Outlet Burnt Terminal

**TIME AND DATE OF INCIDENT:** 11 September 2019

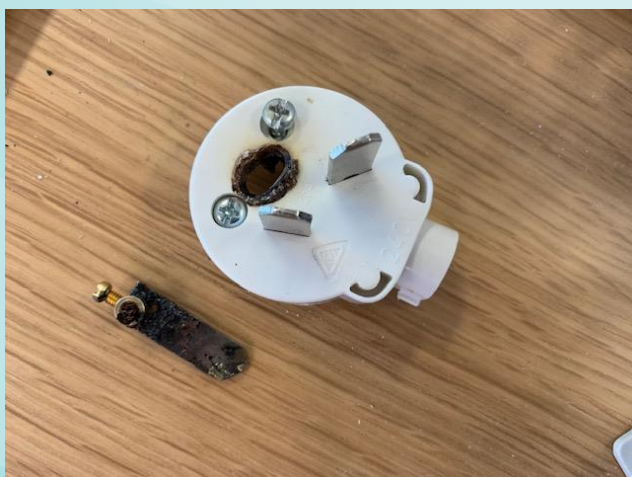
The 20amp socket outlet supplying electricity to a commercial barista-type coffee machine was found to have a severely damaged phase terminal. This terminal was heat damaged due to a loose connection in the plug. This damage was discovered by an electrician checking the machine prior to being relocated.

The loose terminal in the plug has been attributed to a phenomenon where a terminal screw can loosen over time due to thermal cycling.

This thermal cycling of a termination creates voids leading to loose connections, which cause high-resistance terminations that get progressively worse over time.

Thermal cycling can be exacerbated using electrical fittings with small contact patches in the plugs and sockets such as those used in this installation. These domestic-type fittings with smaller contact areas are often installed over industrial-type fittings for economic reasons.

Use electrical fittings with a larger contact area such as industrial-type fittings.

Check all coffee machines to ensure plugs and socket outlets are in a good state of repair. A check of terminations should also be performed. This requires the services of a suitably qualified electrical tradesperson.

Where domestic-type fittings are used, an upgrade to industrial-style fittings is recommended. This requires evaluation on a case-by-case basis.
