SAFETY ALERT

Senior Vertical Horizontz height instructor s Incident

5th March 2014 1530 HRS

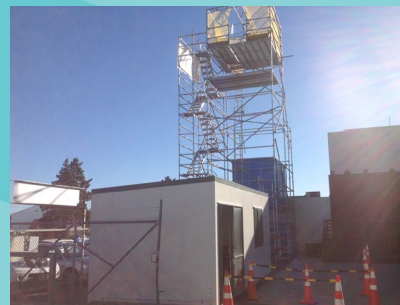
PHOTO:

Vertical Horizontz NZ Ltd were instigated by Industrial Site Services Ltd to carry out Global Wind Organisation height training at the ISS premises. ISS erected a ten metre high temporary scaffolding tower in order to simulate the height of a wind turbine (see Image below) to make the training as realistic as possible. As the day progressed, the number of trainees reduced. At approximately 1500hrs, an ISS employee was the only trainee left to descend everyone else was observing from the ground. The VHG senior instructor ensured that the trainee rigging was safe and he proceeded to complete his descent, leaving the senior instructor alone at the top of the tower. According to a witness

Two witnesses observed the senior instructor descend as far as the top of the container, where he completed *"an abseil bounce off the scaffold at approximately the height of the bottom platform"* (2.5 metres from the ground), *"he appeared to come down straight, without bouncing prior to this – it all happened very fast"*. At this point the trainees all heard the 'thud' of the instructor hitting the ground. The instructor was found on the ground with the rope on top of him. A senior ISS manager asked what happened and the VHG instructor replied 'shit that hurt – I ran out of rope. He was then taken to hospital for assessment and x rays.

- Did not follow best practice
- No Safety back up line was used
- Exhibitionist Showing off
- The safe means of egress was not used(Stairs)
- Complacency
