Safety Alert – Contact with electricity

Incident location: BT Project Site, Museums Victoria, Melbourne

Incident date & time: 21/12/16 @ ~1:15pm

Incident type: Electrical Energy

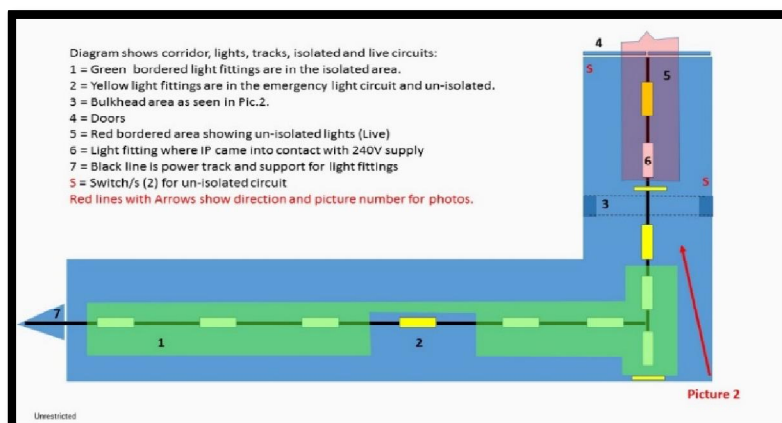
He opened a light fitting and began to disconnect the electrical terminals to remove the fitting from the supporting rail. The fitting he worked on was not electrically isolated and came into contact with the 220V supply when he touched the neutral wires in the terminal block (See Figure 1, below).

Figure 1. Plan of work area with electrically isolated area shaded green. Contact with electricity occurred at (6).

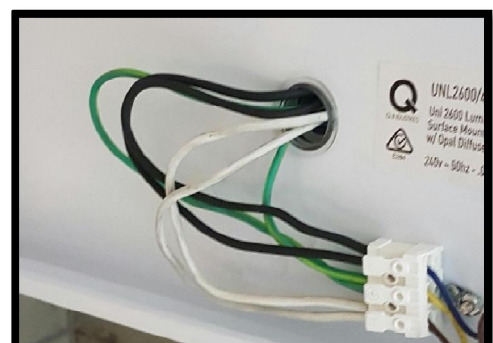
Figure 2. Terminal block in the LED light fitting. Note multiple active (white) & neutral (black) wires used to link this fitting to others in the circuit and that were energised at the time of incident.

1. Failure to recognise boundaries of isolation and to follow Lock Out/Tag Out and test for dead requirements, as required by Work Method Statement
2. Failure to adequately supervise all members of the work group by the sub-contractor, given the team member had just joined this work group after finishing work in another location on site & received no briefing on the scope of work

1. Failure to follow site isolation procedures for risk of electric shock as per agreed controls as detailed in Work Method Statement
2. Personal acceptance of risk when working with electricity, based on skills and experience

Key action required	Responsibility assigned to	Timeframe	Evidence required
Revitalise Daily Prestart process & process implemented to brief any individual who join work teams during a shift put in place	Siemens PM	15.02.17	Updated Pre-Start process; team Member sign-on to all Work Method Statements
Verify implementation of electrical isolation including LOTO as required by sub-contractor Work Method Statement	Siemens PM	15.02.17	Updated Work Method Statement; Inspection to confirm practical implementation
Monitor & check sub-contractor works are completed in accordance with their Work Method Statement/s	Siemens PM	15.02.17	Inspections & Safety Walks
Sub-contractor employee excluded from site	Siemens PM	25.01.17	Communication to sub-contractor
These key actions will be applied across the relevant parts of the business to improve health and safety at Siemens.			Richard Spence EHS Professional Contact: 0427 847 941
