Trailer Steering Failure

North Island

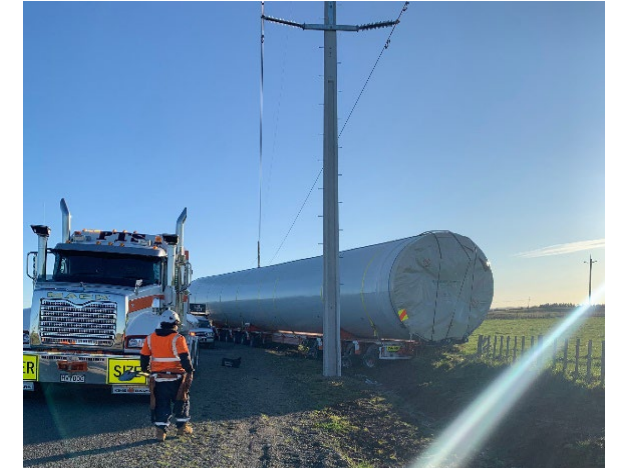
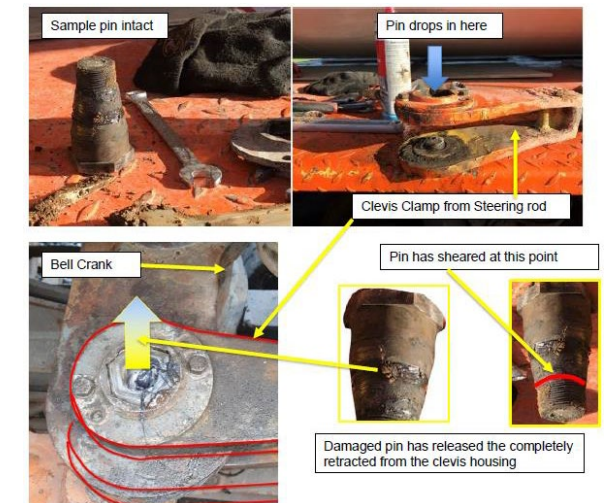
During transport of a turbine tower the trailer unit has become disconnected from the front prime mover after breaking the towing arm and then continued to veer left and off the sealed road surface into a ditch and then coming to rest with the trailer front left aspect buried into the adjacent roadside embankment and having flattened a section of paddock fencing.

The tapered pin that forms a pivot joint on the trailer's steering mechanism failed. Without the PIN or a secondary engineering control within Clevis housing to retain PIN in housing in event of failure, the PIN has dislodged, and the trailer unit did not steer as intended. With this loss of steering, the trailer unit did not follow the prime mover. This in turn has resulted in a jack-knife and secondary draw bar damage and damage to the trailer header.

1. Additional inspection of equipment needs to take place and be verified by a competent person.
2. The pin had not been replaced since 2018, causing significant wear and tear of this component
3. The drawbar pins did not have the correct locking mechanism to secure it casing the top of the pin to dislodge at some point during the trip.
4. The draw bar was not certified as per NZ LT400 certification as it had been shipped from Australia and compliance not conducted.
5. Early acceleration out of turns while the trailer is not tracking straight have the potential to put additional dynamic forces into the trailer
