Ventilation fan blades detached

Thermal: Turbine Hall Roof

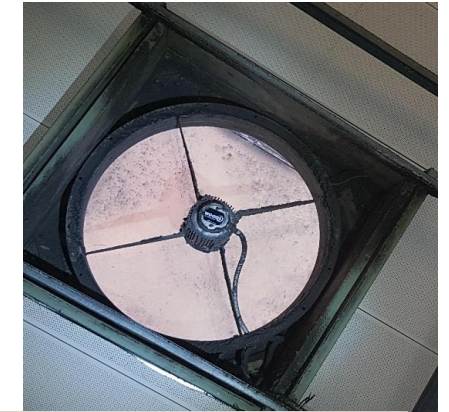
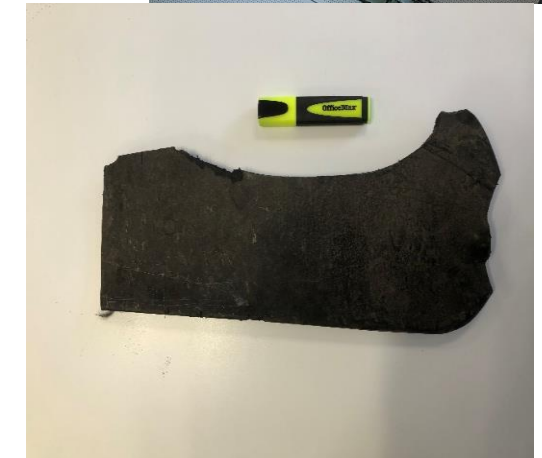
All six blades of a roof mounted building ventilation fan detached whilst the fan was in operation. The fan is mounted 30 meters above the floor in the turbine hall roof, but in this particular location, blades and pieces of blades fell 10 meters onto the below GT enclosure roof. Some blades were thrown out through the ventilation hood onto the turbine building roof.

A bird appears to have flown into the fan causing a fan blade to impact the motor support struts. The ensuing disturbance has led to all six blades shearing off. The blades are a moulded plastic

The external ventilation hood louvers were in disrepair.

There is no mechanism installed that would prevent bird strike or capture falling debris. There are three more ventilation fans in the turbine hall in which a detached blade has the potential to fall the full 30 metres to the floor below.

Fan with missing blades and a Blade
