Dropped linkage arm

Geothermal

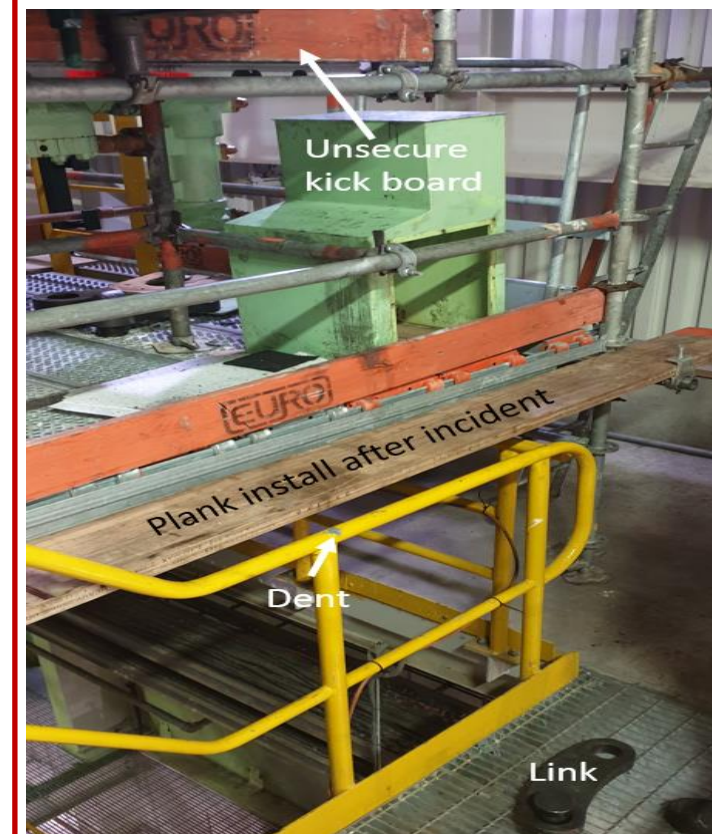
Contractor was working up at Poihipi station on the left Emergency Stop Valve (ESV) bushing on top of a scaffold platform 1000mm X 630mm, while trying to stand bushing up with the aid of a pulley he has knocked one of two linkage arms weighing 19.5 kg onto the scaffold kickboard which has given way resulting in both kickboard and Linkage falling 2.26 meters onto the nearby walkway grating.

- The job scope got bigger than planned.
- The lightening in that area was poor and not addressed
- The work area was confined causing the link to be placed against kickboard.
- The Scaffold kick boards were not fully secured
- Always think of the “what if scenario”. Where could a dropped object fall to and how do we appropriately mitigate for this.

As a result we have created an internal scaffolding standard.
