SAFETY ALERT

Shared Learnings

Dropped cell phone

13th Jan 2022 – 11.30am

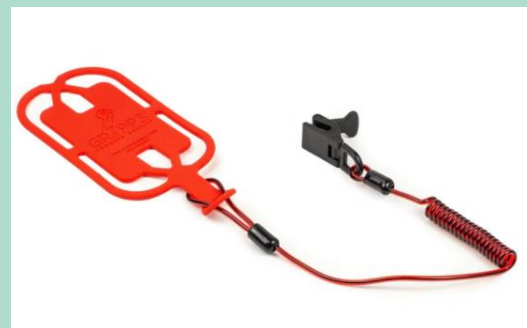
PHOTO:

GRIPPS Phone Gripper \$13.95 each 1

Market research was completed, and a different innovative phone tethering option was found.

- Custom silicon compound made for strength & grip.
- Avoids installing a permanent connector point on a mobile device.
- No additional adhesives required.
- Integrated, load rated tether connection eyelet.
- Compatible with virtually every smartphone model.
- Conforms to ANSI/ISEA 121-2019

It has been requested that all operational wind turbine staff be issued one phone tethering device and the site have plenty of
