Fan Ring Dropped onto Loading Bay Floor.

Hydro

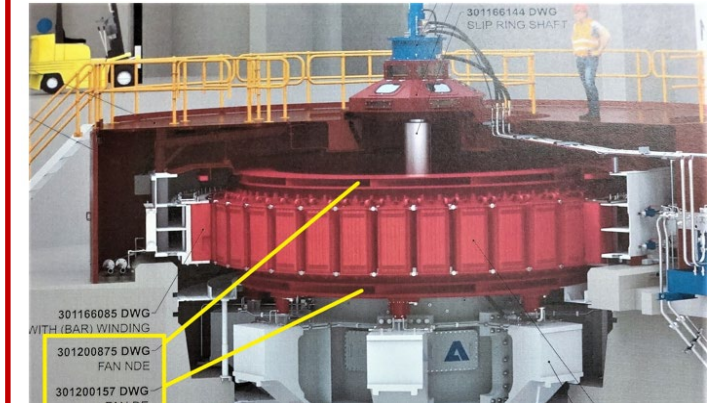
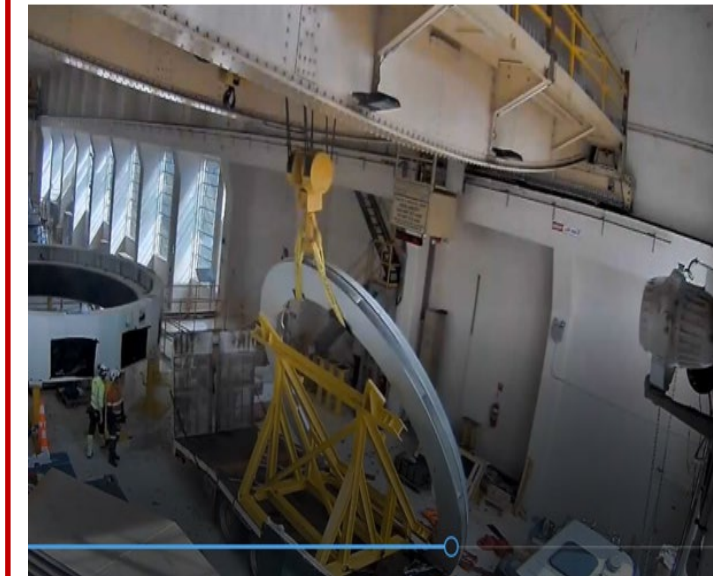
This event occurred when a rotor fan ring weighing 3,975kg was being lifted from a transport frame on a delivery truck using the power-house crane.

The fan ring was the wrong one for this work plan and was loaded upside down.

After preparation for removing the fan unit from the delivery truck, the lift commenced, and the weight of the load shifted causing the fan ring to strike the loading bay floor. A drop of .5m.

Although this was not a significant drop the potential for a more serious incident due to poor management of change in the lifting plan and not adhering to standard procedures had potential to be more serious.

The amended lift plan was not fit for purpose to safely and efficiently perform the lifting task.

Failing to identify the lift change from a 'Regular' lift to a 'Complex' lift the plan was amended in the moment not following a correct risk assessment.

Team believed they were competent to design a new plan.

On further investigation it was also found there was no defined safety exclusion zone - multiple people walked through the lift site.

All changes to safety plans need to be assessed for new risks.

Approved Code of Practice for Cranes must be followed.
