Lifting Eye Failure During MIV Installation

Location: Cobb (Tasman)

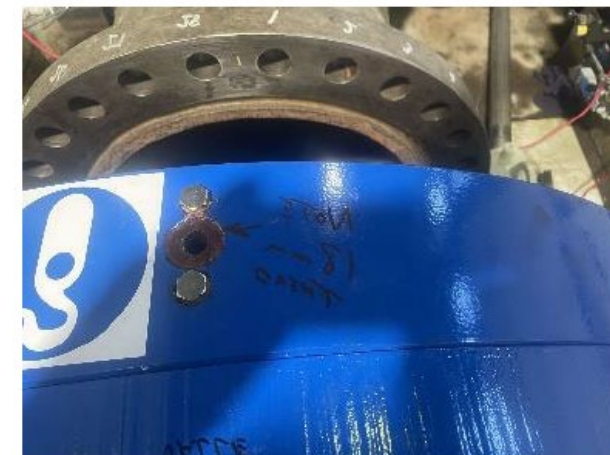
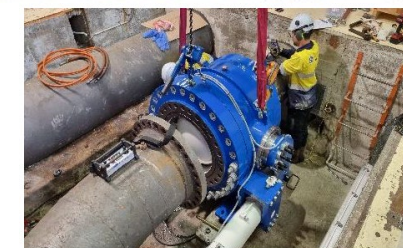
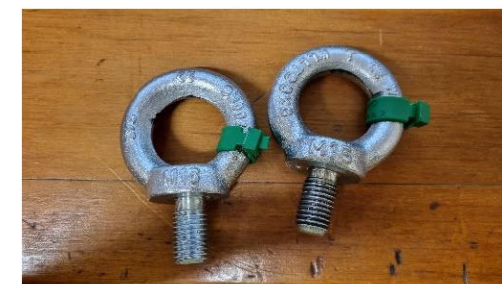
During the Installation of a Main Inlet Valve (MIV) at Cobb station, a lifting eye, failed. The lifting eye rated at 600kg was not one of the main lifting points but was being used by the contractors as an auxiliary to assist in tilting the MIV into the correct position. (Pic 2. Indicative only of description- Contractors were not standing in pit during lift).

The lifting eye supplied with the MIV had a 16mm thread, but the socket on the MIV was threaded at 18mm. The supplied lifting eyes were removed for tagging when the MIV arrived on site. When replacing the lifting eyes with tagged ones, it was not apparent to the contractors that the wrong ones were supplied originally and therefore the new tagged lifting eyes were also the wrong size.

MIV weighing over 4ton, rocked back and forward violently, when the lifting eye failed, but Contractors were standing in a safe location and no damage occurred to the MIV.

- Eye bolts incorrect sizing.
- Eye bolts not certified, so as per procedure were replaced with exact size supplied with the MIV (16mm)
- Eyebolts removed & installed without noticing incorrect size. The Contractor stated there was no indication there was a size difference, No evidence of cross threading. Bolt size was not indicated on the MIV itself.
- Eye bolts not a familiar size. 18 mm Not commonly used in NZ. Nonstandard thread
- No drawings attached as part of lift study, as it was not considered a complicated lift
- New equipment supplied from OS needs verifying by drawings.
- Visual checks of drawing and inspection of equipment no matter if critical or non-critical lift.
- Stop work if unsure and seek assistance.
