Dropped Plate running casing

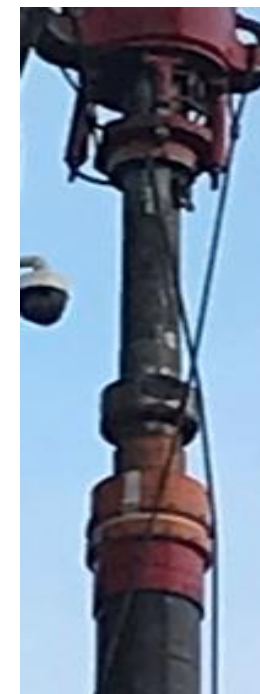
Plate that fell

The process included the use of wire slings to hang the single joint elevator used to lift the casing until the Volant casing running tool is stabbed and set in the casing. When the casing joint has been screwed into the joint below, the Elevator has caught on the casing and rotated with the casing resulting in the wire slings wrapping around the top drive. The slings have caught on the edge of the IBOP (inside blow out preventor) actuator plate, the force was sufficient to shear the 4 x 16mm retaining screws, allowing the 4.3kg plate to fall to the rig floor.

The plate fell from approx. 14.5 meters height.

Wire slings rotated with casing causing the plate to drop.
