Dropped Object from Crane

Wind Asset

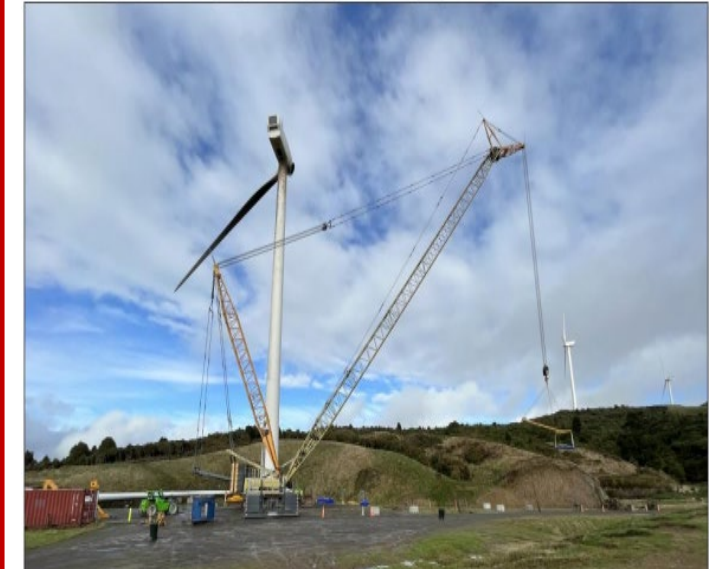
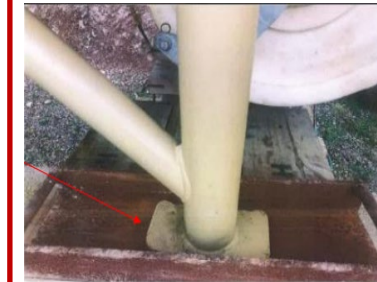
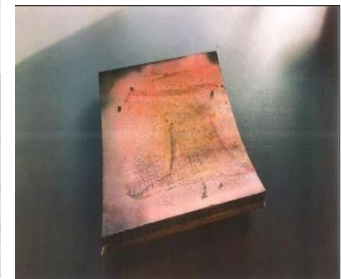
During a lift to refit the blades after a yaw ring replacement a loud thud was heard from inside the drop zone. On investigation a piece of steel dunnage approximately 1m steel channel section fell from the boom tip approximately 70 meters to the ground.

Channel section stuck to boom legs due to the compression of rubber pads creating a vacuum and acting as a bonding agent to both the crane boom foot and the steel channel section.

Rubber pads located between the boom foot and the channel section piece of steel.
