Electricity | Failure of SCE – Final Element| Te Huka Binary

Turbine Stop Valve on Te Huka Binary Plant.

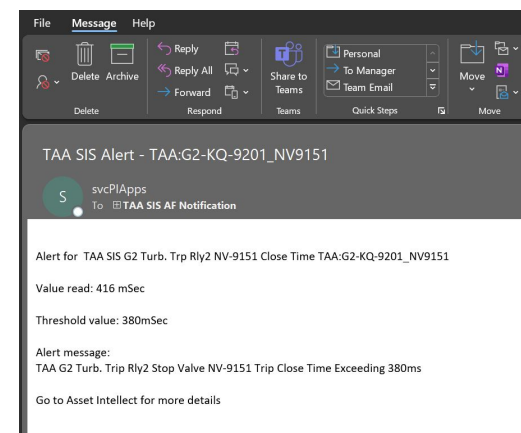
The automated valve performance monitoring system which tracks ESV stop valve closure performance noted that one of the ESVs just fell outside the alarm setpoint and this automatically flagged to the Technical Team. Review of the valve trace data (opposite). Showed the valve performance had slowed from commissioning and while currently meeting the safety performance had degraded.

The unit was returned to service as the valve still meet the safety requirements, and a trial of performance of all ESVs was programmed.

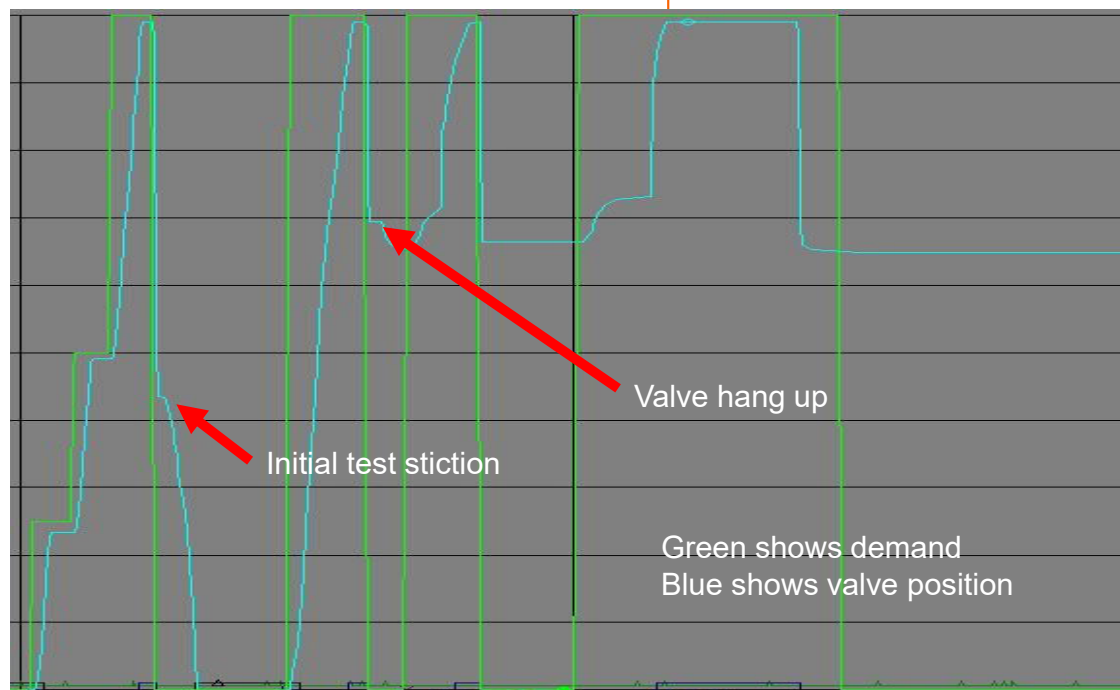
The trial of all ESVs was undertaken and the trace for the suspect stop valve is shown opposite. It can be seen that on first operation the valve was slow to close with speed dropping significantly from what was expected from 50% to closed.

On the following tests the valve hung up between 60-70% closed. The test was stopped and the unit remained shutdown.

The valve subsequently closed under spring actuator force once the unit had cooled.

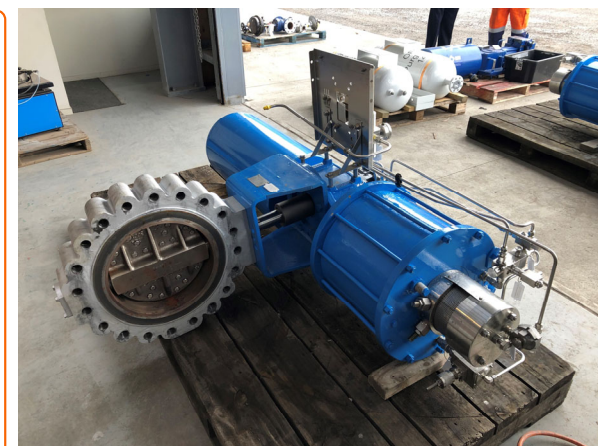
Ongoing investigation of the valve showed that the pneumatic actuator once decoupled operated as designed, which suggests that the problem is internal to the valve. This will require the binary plant to be decanted and purged to enable the valve to be removed for inspections. This activity is currently being programmed.

We will also remove at least one valve for a comparative cross-check. At this point it is too early to make an assessment of root cause, whether is a systemic fault or unique to this valve. Investigations are ongoing.
