Safety Alert

Embedded cable – drilling near-miss

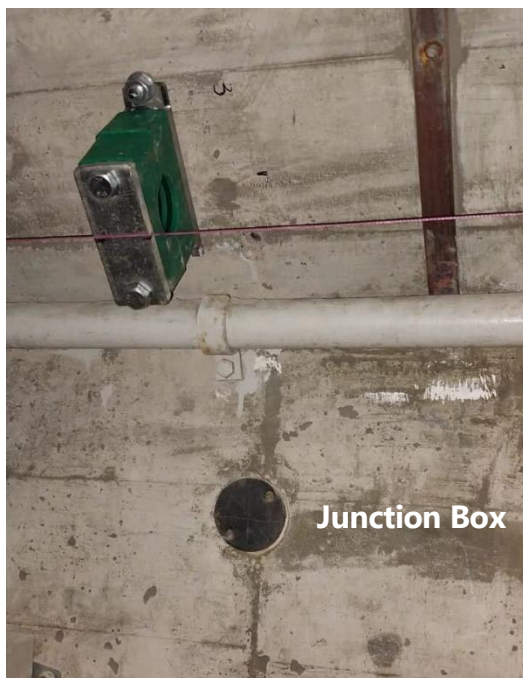
A contractor was drilling into a concrete wall in the power station when they made contact with an embedded lighting cable. No injury occurred and work was stopped until a scanner arrived. The drill used was double insulated, held a current test tag, and was used with an installed RCD.

Although it was verbally communicated to the work party to not drill in line with any junction boxes, the older style junction box was not recognised by the workers. The use of scanning before drilling would likely have avoided this event occurring.

- Scanning should be performed to identify embedded cables, particularly where no up to date drawings are available
- Ensure contractors are aware of the location of junction boxes and can recognise the older style (pictured).
- Importance of pre-works and communication with contractors by the site rep at daily toolboxes
- Follow guidelines contained in the [Cable and Services Work Practice](#) (M-Files ID 137335) when planning penetrations
