SAFETY ALERT

HV Permit Process Failure

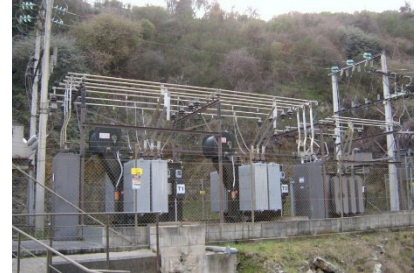
During the commissioning of G2 11kV switchgear cubicle and circuit breaker, three tagged earthing leads were inadvertently left connected to the G2 11kV terminations on the Local Services

Transformer. This resulted in blown fuses. The earths were subsequently removed, and the project engineering team was contacted to source replacement fuses to restore the asset to full operational readiness.

- ❏ The presence of multiple permits and isolations contributed to confusion and resulted in temporary earths not being identified for removal. Leading towards an unclear handover from the team completing the isolations and earthing process as part of the original operating order.
- ❏ Visibility of applied earths was not clear when the site team completing the commissioning completed a walk around to check them.
- ❏ Although labelling and documentation clarity did not directly cause the oversight, their improvement was highlighted as essential to avoid future occurrences.

- ❏ **Single Line Diagrams:** All HV permits will incorporate up-to-date Single Line Diagrams clearly indicating the position of applied earths, with P&IDs attached directly to permits
- ❏ **Labelling:** A robust labelling system for temporary earths and critical components will be implemented, ensuring unique and clear identification.
- ❏ **Training and Competency:** PER and PEG HSW management will continue to conduct monthly reviews of completed permits and operating orders to reinforce process compliance and improve staff competence.

- ❏ Update the permit procedure to mandate the inclusion of site-specific Single Line Diagrams where relevant.
- ❏ Enhance the labelling protocol to clearly and distinctly identify temporary earth connections.
- ❏ Distribute a safety alert company-wide to communicate key learnings from this event clearly and promptly.
