# KAIWERA DOWNS

## Critical Risk Dropped Object

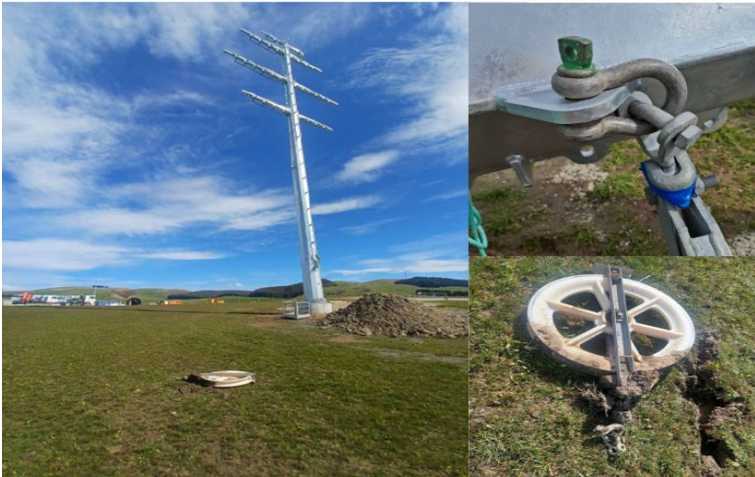
Timberlands running block fell approximately 36metres from the Earth Peak crossarm to ground level.

The block had been secured to the crossarm using a 4.75-tonne green pin rigging shackle.

Wind speeds exceeding 100 km/h caused significant vibration and movement of the block, which caused the shackle pin to gradually unwind resulting in the block detaching and falling to the ground.

Figure 1. Distance from the pole to the ground where the running block had fallen. Shackle used without a secondary restraint.

A running block fell 36m from a transmission pole during extreme winds due to the use of an unsuitable shackle without a locking mechanism, highlighting the need for improved rigging procedures, risk assessment, and use of locking-type shackles.

- **Design:** Inappropriate shackle (finger-tightened type) used to hold the running block that was not under tension. This rigging configuration was lacking a secondary restraint or locking mechanism.
- **Risk management:** The risk and controls to mitigate this risk, were absent from the risk assessment.
- **Procedures:** No procedures related to rigging activities mention the type of shackles that should be used or not used onsite.
- **Strengthen learning opportunities:** Use incident as a chance to understand system factors and share insights for collective improvement.
