## Vehicle vs Power Pole

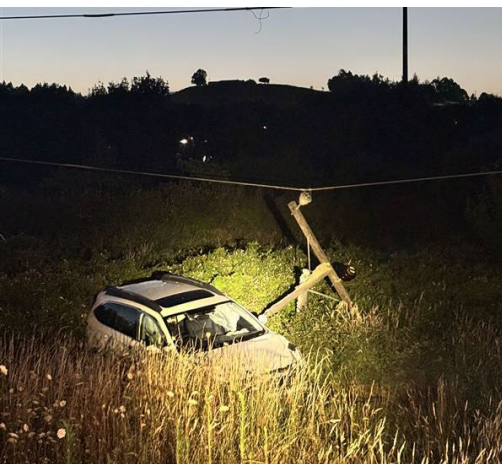
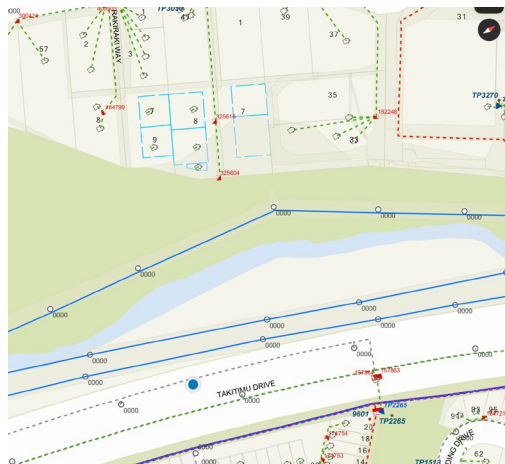
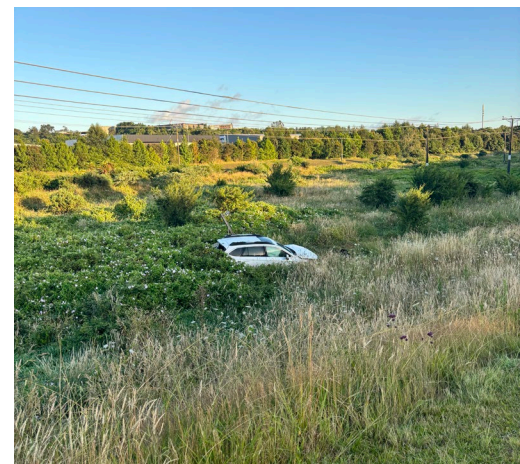
A vehicle collision with a power pole triggered a multi-party emergency response involving Contact Operations, Line Companies. Our team demonstrated excellent safety practices, rapid decision-making, and strong collaboration under pressure. The KMI Generation was safely shut down within minutes, and all three lines were systematically de-energised, earthed, and progressively restored as safety allowed.
