Shared Learning

Critical Risk: Mobile Plant

Trench Collapse – Vehicle Rollover

North Island Solar Farm

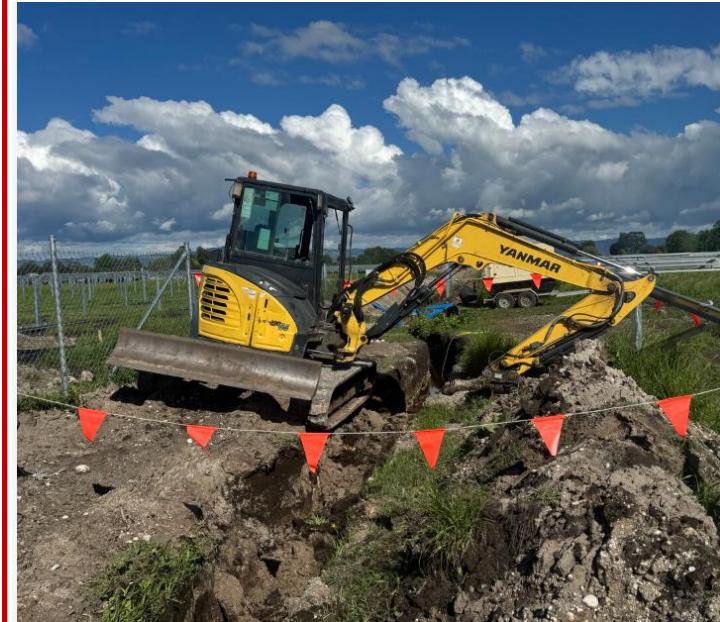
Once stationary, the operator slewed the boom over the open trench section and the trench wall collapsed.

The excavator slipped into the trench. The trench had been open for some weeks and the site had endured approx. 40mm rain over a 48 hr period.

The operator chose to perform a task that was not inline with the SWMS – Minimum 1m distance must be maintained between plant /equipment and trench edge.

Post weather event inspections were not conducted to review the integrity of the site and any open trenches before works commenced.

Spotter was position behind the excavator and therefore was not guiding movements.

Picture of excavator when it slipped into trench after wall collapsed
