Cracked Welds Detected on Oil Cooler

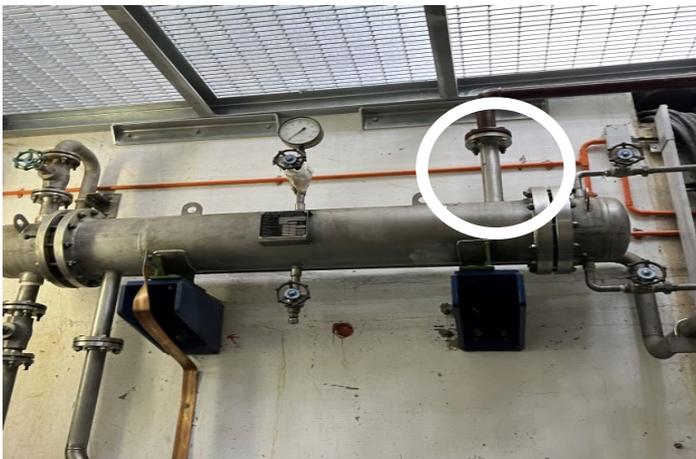
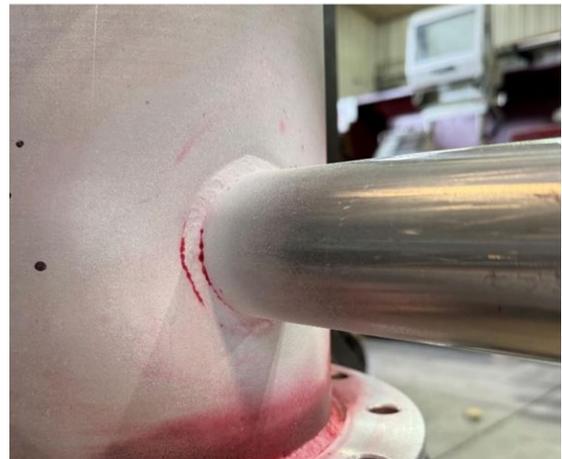
During planned unit outage, deformation was identified on the oil cooler shell and piping. This prompted additional checks, which revealed cracking in the welds. The damage is likely the result of in-situ loading from pipe stresses over time. The defect had the potential to develop into an oil leak with environmental and machine reliability risks. Fortunately, the issue was detected early enough that repairs can be completed without affecting the wider outage, avoiding the unplanned downtime that would have occurred if the failure happened during normal operations.

- Planned inspections were effective in identifying the defect before failure.
- Station design—including sump drainage and the inline oil separator—minimises environmental risk from any release.
- Detection prevented disruption to the outage; outside of outage conditions, downtime would have been likely.
- As the organisation grows, sharing engineering-related defects more broadly would support wider learning and risk reduction.
- Stress related failures are a risk for pipework and associated equipment that warrants periodic inspections.
