Safety Alert

Roxburgh Power Station

9th May 2016

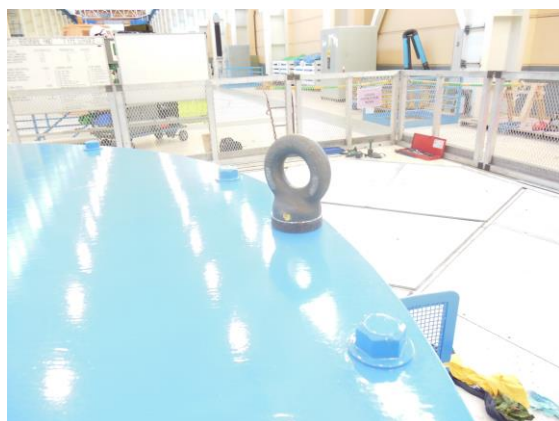
A large steel plate arrived from a supplier with the lifting eyes already fitted. When we checked the lifting eyes were found to be the wrong thread for the holes in the plate. The plate weighs in excess of 1600 kg's. The lifting eyes were the correct rating. The diameter of the thread on the lifting eyes is 30mm. The diameter of the hole into which the lifting

eyes had been threaded is inch and a quarter BSW or 31.8mm diameter. This means that the hole is 1.8mm in diameter bigger than the thread on the lifting eye. The eye bolts could easily have pulled out during a lift.

Removed the lifting eyes from the plate. Contacted the supplier to advise them of the problem.

It's important to remind staff about the importance of checking with someone who understands threads and diameters before trusting lifting equipment that has been installed by a third party.
