SAFETY ALERT

Equipment Falls from Height

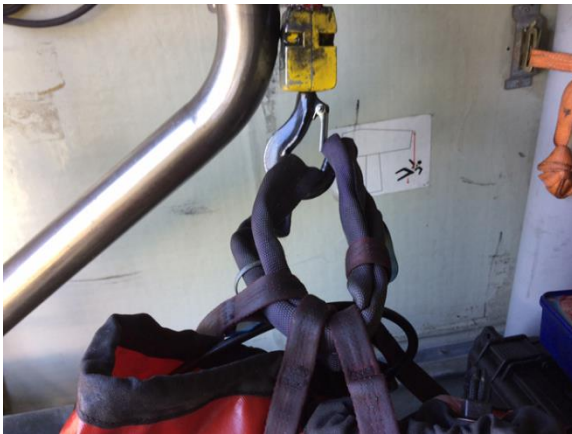
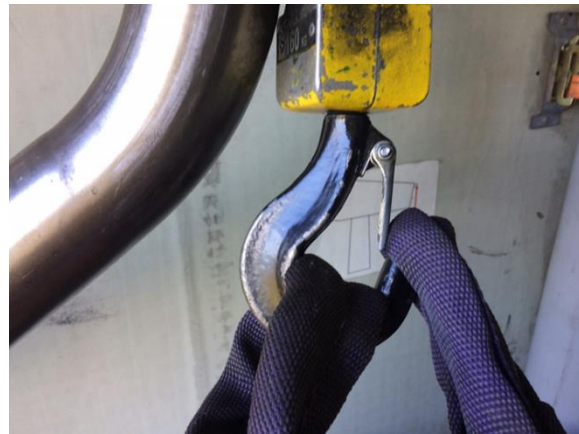
During the investigation the worker responsible explained that a 'basket hitch' method to sling the load was used. It appears that one end of sling was connected to the crane hook, but the other end did not connect with the hook as intended. The worker was not aware of this until the load was presented to the force of gravity.

Enactment shows 'Basket Hitch' method used and non-closure of hook

- 🕒 A drop zone plays a vital role during any lifting operation. The site supervisor had set up and was actively managing the drop zone for the duration of the activity. In an area where personnel or the public may be present below, had no drop zone been identified and managed, this event could have had a catastrophic result.
- 🕒 Always ensure the load is secure on the hook prior to commencing any lifting operation.
- 🕒 If using a single hook, check that it is an appropriate size, whether it is multiple slings or a single sling load.
- 🕒 If using a carabiner and shackle system, ensure it is suitably rated for the lift.

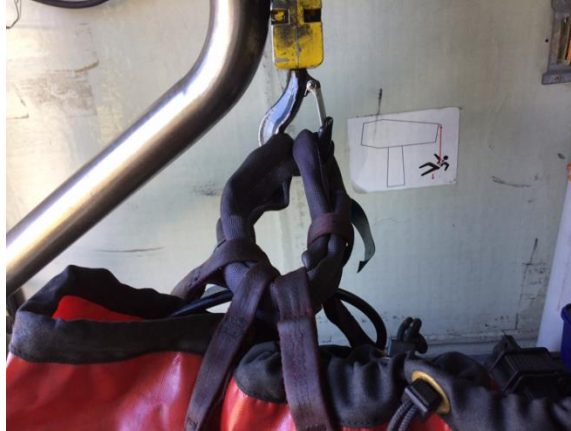
Enactment shows 'Basket Hitch' method and proper closure of hook
