SAFETY ALERT

FAILED LOAD RING (PINKIE)

C Moore
I Williamson
24/07/2019
2019-33
EVT-1020926

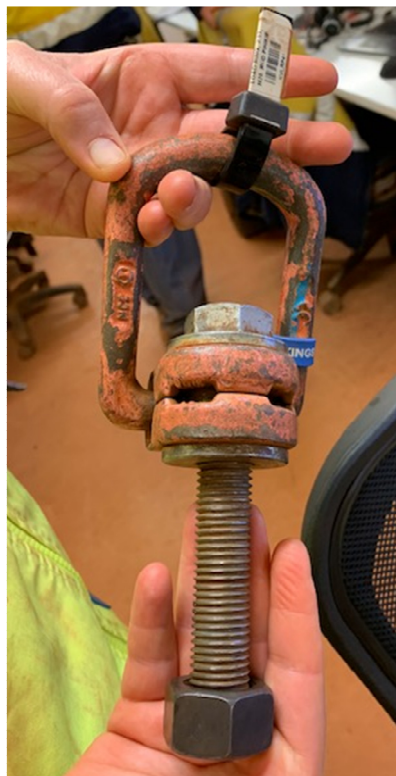
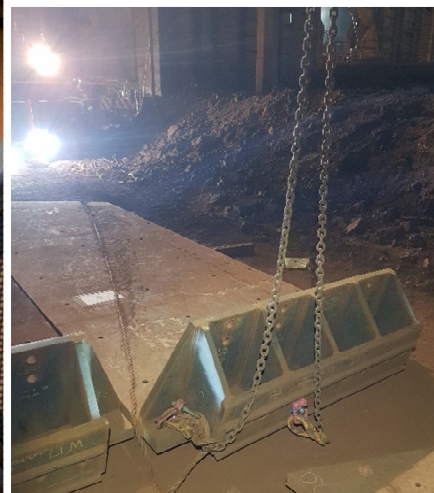
A test lift was being performed on a bin liner with two client supplied load rings (also known as pinkies). As the bin liner has been lifted, the nut from one of the pinkies has stripped off the bolt resulting in the pinkie being removed from the anchor point while under load. The other pinkie has maintained its hold on the load allowing the crane operator to lower the load back to ground safely.

- Incorrect size and grade nut used on pinkie – imperial sized grade 8.8 nut placed on metric 20mm bolt (minimum grade for lifting is 10.9)
- Rigger failed to adequately check the rigging prior to commencing lift

- Ensure all load rings (pinkies) are supplied with correct nuts and other fit for purpose components
- Riggers must thoroughly check all rigging gear and connections prior to undertaking any lifts
- Test lifts must be conducted for all lifts
