Crane Operator – Fractured Wrist

North Island Wind Farm

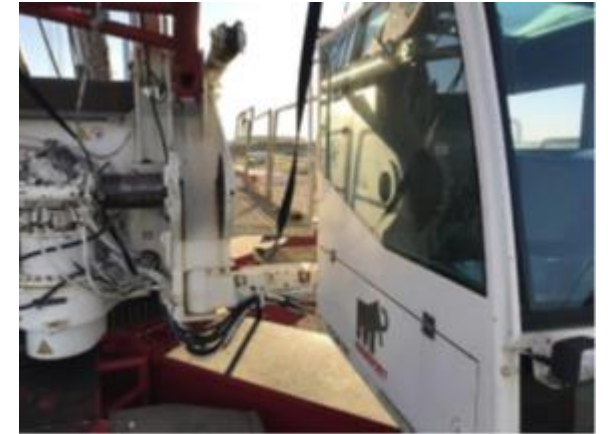
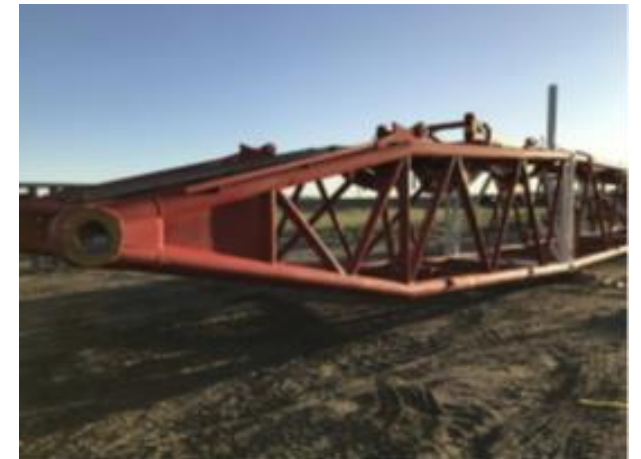
At approx. 1515 hrs, the IP was overseeing and assisting with the removal of boom sections from the Terex TC2800-1 main crane at WTG 07. While releasing the heel pins to remove the boom butt end section, it has moved suddenly towards the crane cab which is immediately adjacent to where this section's hinges are located.

The IP has attempted to halt the movement of the crane boom's butt end hinge section towards the crane cab by placing his left arm between the crane cab and the moving boom section.

This resulted in his left wrist being hyper-extended as his forearm was positioned between the crane cab and the boom section. The IP experienced immediate discomfort.

Failure to fully risk assess potential for crane boom butt end to move suddenly in an unplanned direction once heel pins removed and any stored energy is released.

- Arm was placed in bad position whereby it could be caught between the moving crane boom section's heel and the side of the crane control cabin
- Crane arm moved suddenly and in an unexpected direction toward the Cab
