# Shared Learning

Working at Height | Scaffold collapse under high wind loads | Geothermal site

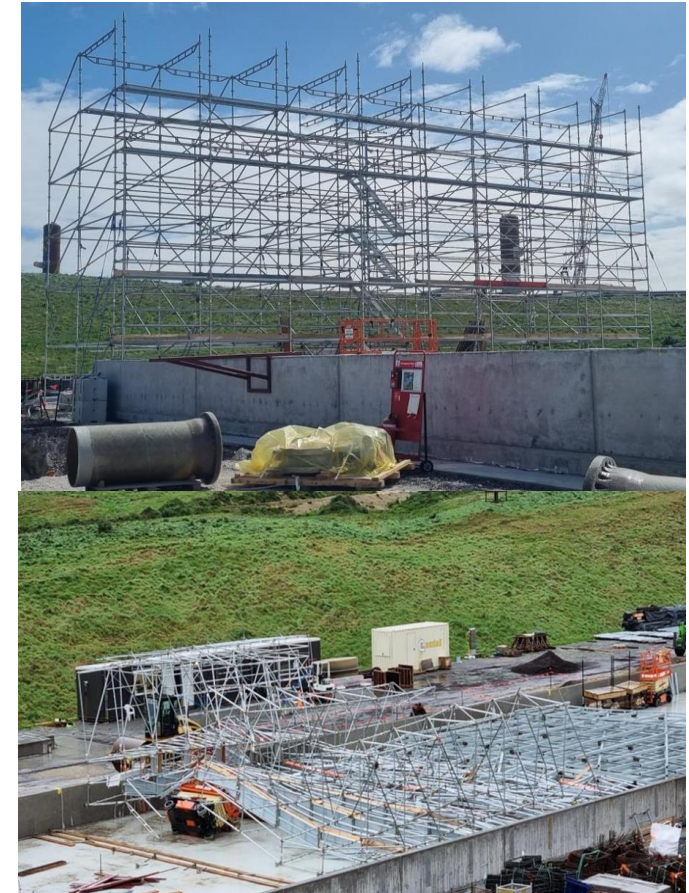
A scaffold 16m High x 5m Wide in the cooling tower basin collapsed onto its side.

The original design included the use of tie downs but a change from the original design occurred as holes were not permitted to be drilled in the basin of the cooling tower.

There was no one onsite at the time the scaffolding collapsed, and we experienced very adverse weather, high wind loading.

It was observed several times prior to the event that the scaffold was rocking or looked unsafe.

- Safety Controls must not be compromised
- Consider the management of change process.
- The risk of inclement weather exposure (i.e., high winds/gusts) should be included in onsite risk assessments.
- Establish a culture which invites the ability for anyone on site to ask questions, raise concerns or challenge an instruction. Everyone must have the ability to challenge decisions if something looks unsafe.
- As leaders, follow up on concerns or safety observations raised.
