## Shared Learning

Critical Risk: Stored energy

## Water blasting roof - Injury

## Location: Roof of Station

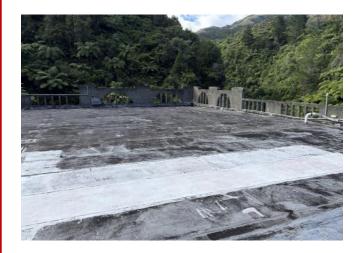
## Location of incident

Two contractors were water blasting the roof of the power station to clean the surface before applying a waterproofing topcoat. The roof is flat, with a concrete-set handrail around the perimeter. One worker was operating the water blaster, while the other was assisting by maneuvering the waterline to improve access. During this process, the assisting worker slipped on a recently water-blasted section of the roof. As he was falling, his hard hat fell off, and the water jet briefly made contact with his head, causing an abrasion injury.

• Identifying Hazards: Stay alert for unexpected hazards. The section of the roof where the worker slipped had a different traction due to a historic paint job, which may have contributed to the fall. Regularly inspect work areas for anything that's different or unusual.

• **PPE Suitability:** Although the contractors were wearing PPE, including safety boots, safety glasses, and hard hats, the hard hat lacked a chin strap. Always ensure that appropriate PPE is selected based on the specific hazards involved in the task. In this case, a chin-strap hard hat/safety helmet would have provided better protection from injury.

• Work Area Safety: Only those directly required for the operation of the equipment should be in the immediate work area (line of fire zone). Use exclusion zones and barriers to separate other workers from potential hazards and maintain a safe distance for observers.
