# SAFETY ALERT

## What happened

A contractor at Te Apiti Windfarm was cleaning one of the levels in a turbine. He bent down and his radio fell out of the holster. It hit the closed hatch, then fell down the turbine, approx. 18m. No one was working below.

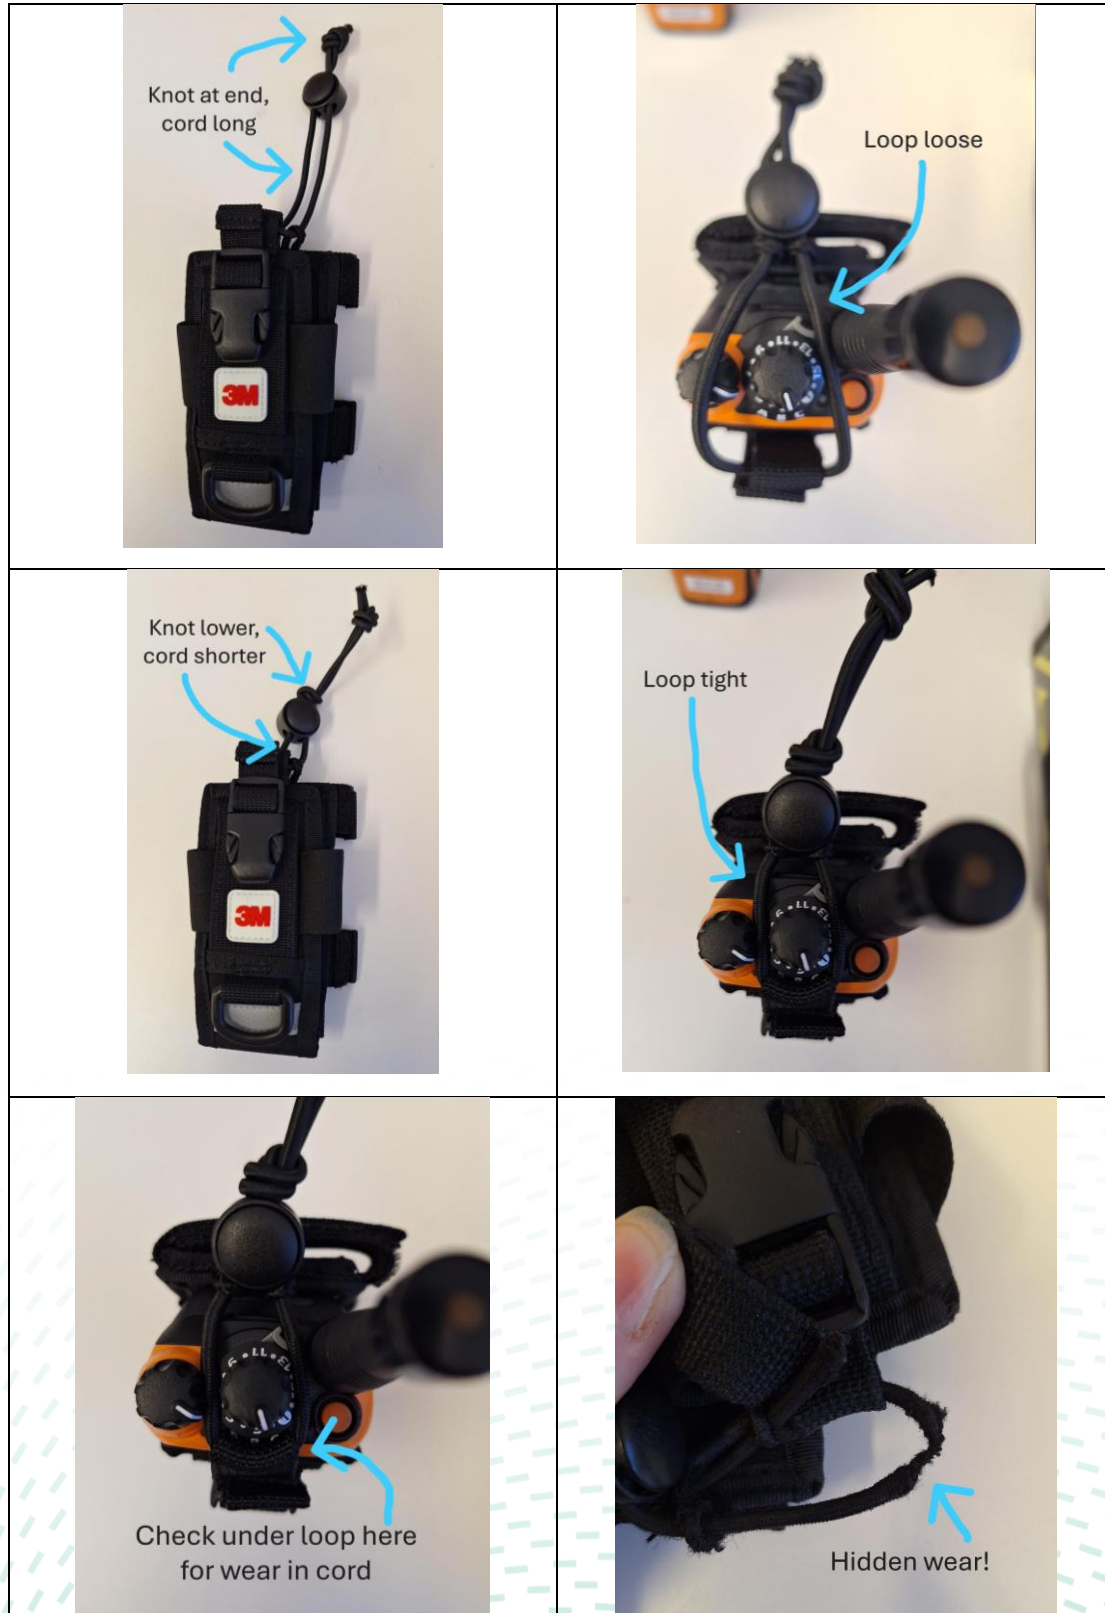
- The radio holster was checked after the event and the elastic cord holding the radio was too long. When the securing catch moved, it created a gap that allowed the radio to fall. See photos following.
- This is a great opportunity to highlight that the cord should be as short as possible to secure the radio in place.
- This also resulted in closer inspections being carried out on all holsters, highlighting another area of potential wear.
- It was great that the holster was being used, and that the hatch to the lower level was closed. These are key safety precautions in place for working in turbines safely.

- Radio holster checks will be included in monthly harness checks.
