## Event – CT Chamber Arc Flash Incident

## Location - Customer's premises

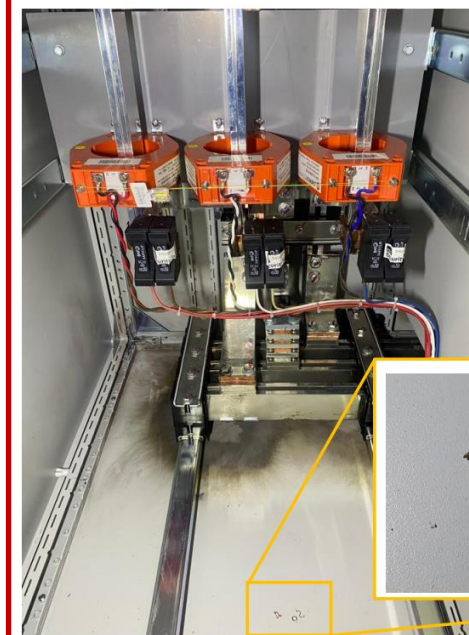
## CT Chamber, post-event

The ICAM investigation concluded that a piece of swarf left in the CT chamber during manufacturing or installation became mobile due to windy conditions and open doors, eventually contacting the lower red-phase busbar strap and triggering an arc flash. The resulting gases then ionized, resulting in a flashover across all three phases. It is extremely fortunate that this did not occur while the technician was working inside the CT chamber, moments earlier.

Swarf (metal drill spoils and copper strands) had not been removed from the CT chamber from previous work activities. This debris may have been blown or fallen into the chamber from above, through gaps in the chamber ceiling.

The switchboard design, although compliant, may have increased the risk of an arc flash event e.g. exposed bus work, which was not insulated or behind covers, clearances between phases and the CT chamber position.
