# Shared Learning

## Critical Risk: High Voltage Electricity

### *Tipping near 33kV transmission line*

### *Eastland Generation TOPP2 Power Plant*

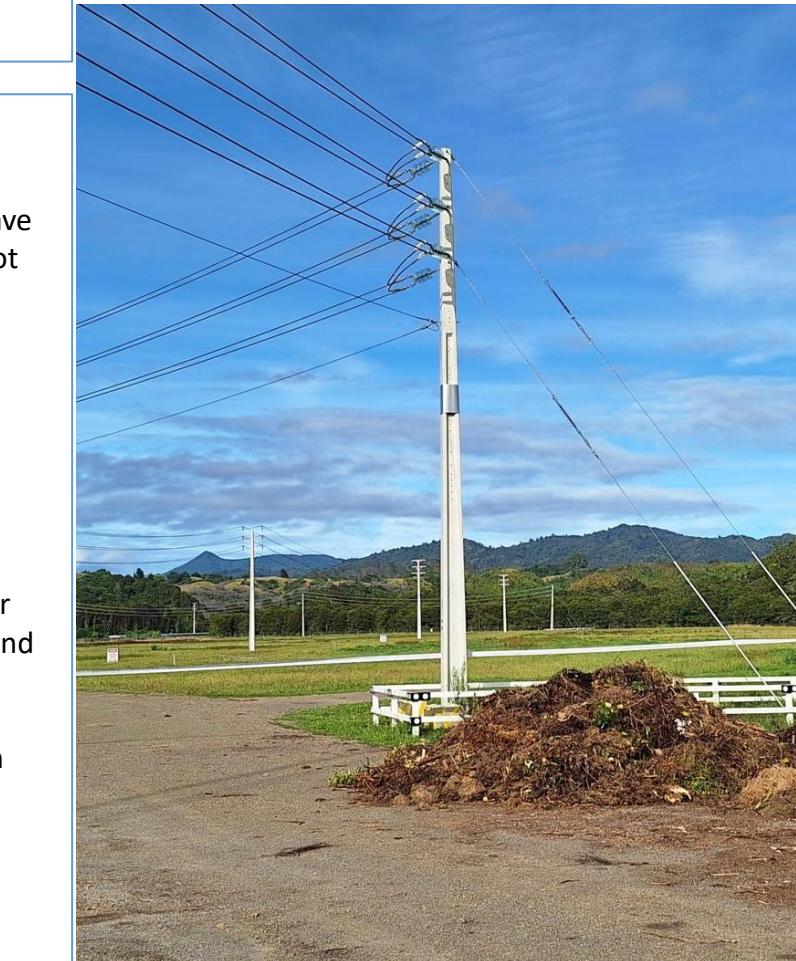
During the inspection of a recently commissioned 33kV transmission line, a pile of green waste was discovered in very close proximity to the line.

Investigation at the location and subsequent review of CCTV footage confirmed that tipping activities had been undertaken directly beneath the live 33kV transmission lines.

While no personnel were injured, the incident represents a high-potential event. Had mobile plant contacted the transmission line during the tipping operation, the activity could have resulted in a fatal electrical injury.

Corrective actions focus on reducing the opportunity for such behaviour through stronger engineering controls including fencing along road sides in close proximity to the live high voltage transmission lines. Strengthened procedural, and governance controls have also been recommended.
