SAFETY ALERT

What Happened

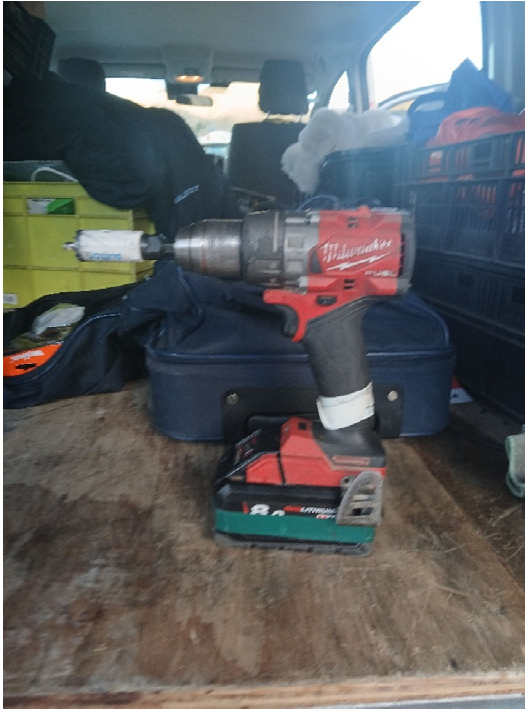
A Worker from a Subcontractor was drilling a 20mm hole into a steel post to install sensors for a new security gate. The hole was drilled with a standard Milwaukee M10 battery drill with a 20mm hole saw bit. The worker was in a haunch position on one knee. When the hole saw punched through the steel it got stuck and the drill kicked back hitting the worker under the chin with the battery area

Milwaukee M10 Drill

The clutch on the drill was not set to a setting where the drill will disengage when it bites into the drilled object.

A side handle of the drill was not used.

The clutch on the drill must be used to ensure there is no kickback.

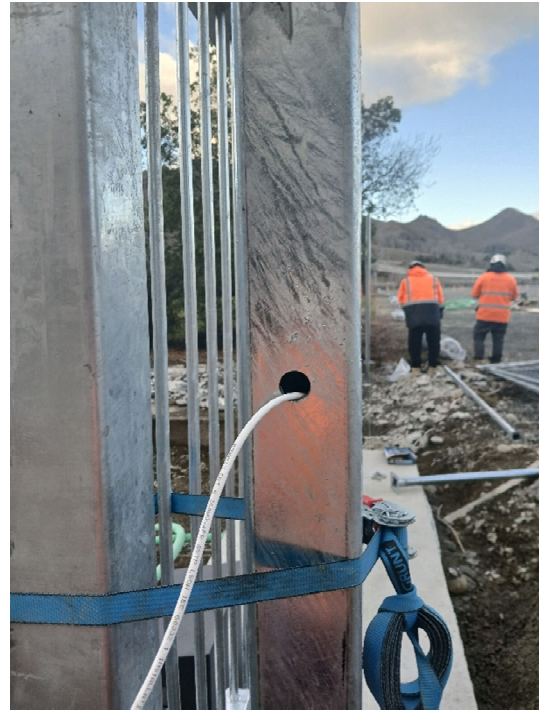
Hole drilled in post

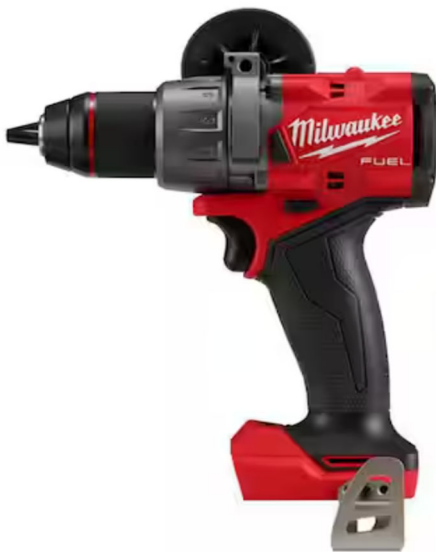
Milwaukee M10 with Handle attached and Clutch visible

A Handle for small drills will be needed for all this type of drilling.

Alternative drilling tools and techniques like a Mag Drill was discussed but it was found that the M10 drill with a side handle and clutch being set was fit for the job.

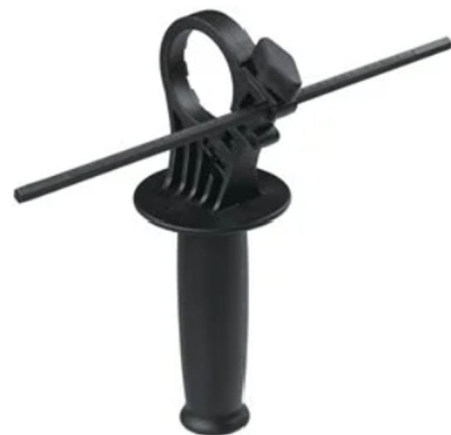
M10 Side Handle
