# Shared Learning

## Critical Risk: Stored Energy

### *Shooting Nipple Event*

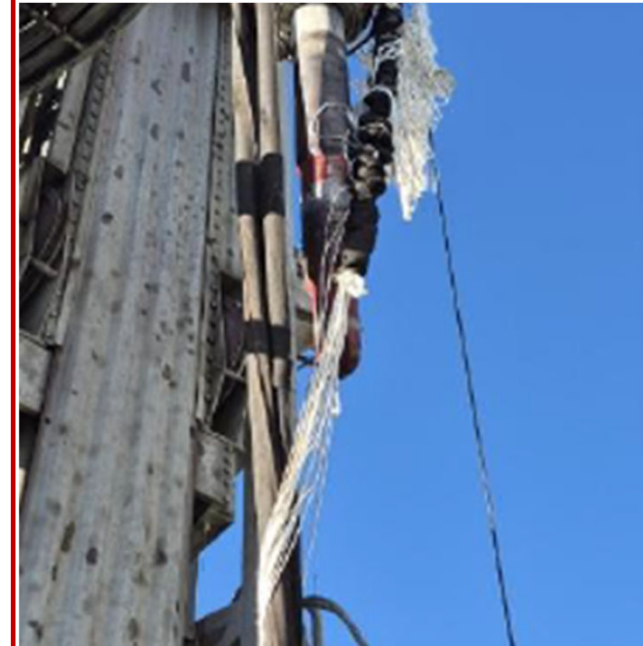
### *Photo: broken sling*

During the lifting process, one of the soft slings failed.

This caused a sudden release of stored energy propelling the shooting nipple upwards through the BOP stack several meters but contained within the rotary table.

During the retrieval operation, the slips were pulled in one direction, which contributed to the misalignment of the shooting nipple, this caused the lower end of the shooting nipple to shift into a cavity within the BOP stack, where it became hung up.

The existing shooting nipple retrieval process did not adequately recognize the importance of maintaining alignment during lifting operations or while handling the slips.

Engineering Control - two centralizers were fabricated and clamped round the shooting nipple to mitigate misalignment failures during this operation.
