# Safety Alert

**INCIDENT TITLE:** Coffee Machine Socket Outlet Burnt Terminal

**TIME AND DATE OF INCIDENT:** 11 September 2019

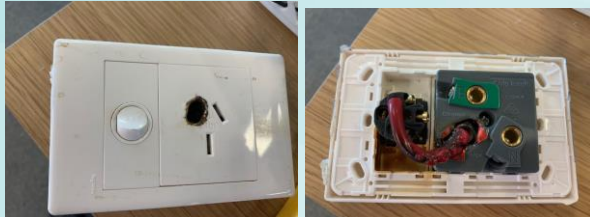
The 20amp socket outlet supplying electricity to a commercial barista-type coffee machine was found to have a severely damaged phase terminal. This terminal was heat damaged due to a loose connection in the plug. This damage was discovered by an electrician checking the machine prior to being relocated.

Had this damage not been discovered, there was the risk of a fire occurring or the creation of an electrical shock hazard.

The loose terminal in the plug has been attributed to a phenomenon where a terminal screw can loosen over time due to thermal cycling.

This thermal cycling of a termination creates voids leading to loose connections, which cause high-resistance terminations that get progressively worse over time.

Had the termination been loose from the original installation, a failure would likely have occurred much sooner. This coffee machine was in daily use over the past few years without incident.

Use electrical fittings with a larger contact area such as industrial-type fittings.

Check all coffee machines to ensure plugs and socket outlets are in a good state of repair. A check of terminations should also be performed. This requires the services of a suitably qualified electrical tradesperson.

Where domestic-type fittings are used, an upgrade to industrial-style fittings is recommended. This requires evaluation on a case-by-case basis.
