### Motor Heater circuit electric shock

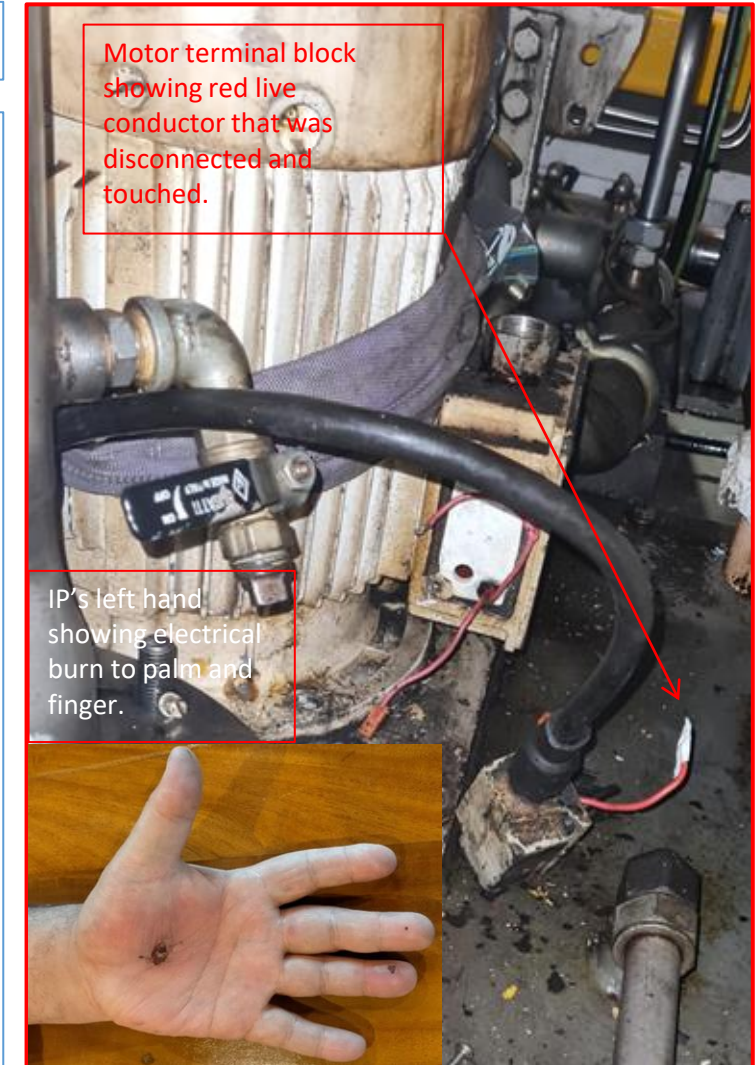
The IP electrically disconnected the DC lube oil pump motor and disconnected the 415VAC lube oil pump motor without issue. He discovered a second smaller terminal block and assumed it was a low voltage thermistor for the motor and disconnected it, failing to check it was deenergised, and received an electric shock and burn to the palm of his left hand, when he touched a live conductor on what was an unisolated 230VAC motor heater circuit.

IP misidentified equipment and subsequently failed to test it was deenergised (*Electricity (Safety) Regulations 2010. Regulation 100 makes it mandatory to comply with standard AS/NZS 4836*). Always check a circuit is deenergised before working on it.

Motors can have more than a single power source. Ensure when applying isolations that this is understood.

- Electrical drawings for motors with heaters or other circuits carry a warning and drawing reference to the heater or other circuit.
- All motors with heaters or other circuits carry a label stating this at the terminal box.
