Electric Shock 230VAC Incident

Motor Heater circuit electric shock

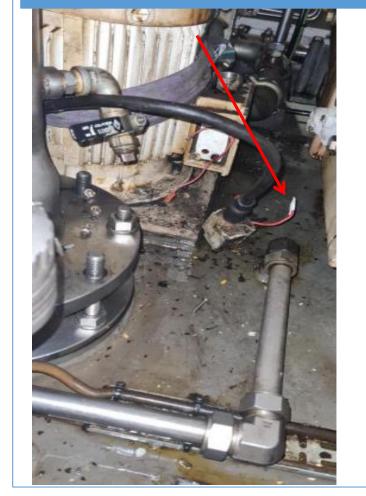
The IP electrically disconnected the DC lube oil pump motor and then disconnected the 415VAC lube oil pump motor. The IP discovered a second smaller terminal block and assumed it was a low voltage thermistor for the motor. He disconnected this terminal block without checking it was de-energised. The IP received an electric shock and burn to the palm of his left hand, when he touched a live conductor on what was an un-isolated 230VAC motor heater circuit

Motor terminal block showing the live conductor that was disconnected and touched

Always check a circuit is deenergised before working on it and never assume.

When applying isolations ensure that you understand if there could be more than a single power source, such as motors.

Electrical drawings for motors with heaters or other circuits carry a warning and drawing reference to the heater or other circuit.

All motors with heaters or other circuits carry a label stating this at the terminal box.
