Dropped Pipe from a truck bed

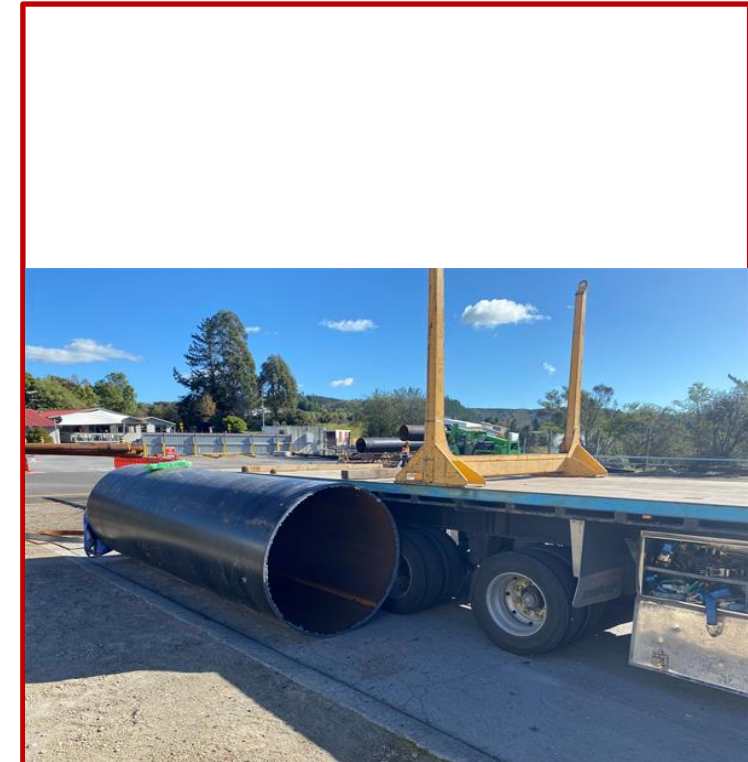
An approx. 4m x 1350mm pipe, was being loaded onto a truck using a Merlo Telehandler. However, the pipe slipped from the Telehandler's jaws and rolled off the opposite side of the truck, resting on the ground beside the vehicle.

- No chocks/dunnage on the trailer deck to stop the pipe from rolling off.
- The Merlo's jaws were not sufficient to hold the large 1350mm diameter pipe securely.

The pipe on the ground beside the truck.

1. When loading any pipe, ensure the correct Merlo attachment is suitable for the job being used.
2. When the job changes, re-assess the method, including associated risks and controls, and ensure the JSA is updated.
3. Where possible use stanchions fitted to the truck/trailer.
4. If this is not possible or practicable, make certain to place chocks/dunnage down on the deck before loading.
5. Ensure there is demarcation of the loading area including the far side of the truck.
6. Consider utilising an extra spotter when loading pipe to control area entry.
