# Shared Learning

Critical Risk: Stored Energy

## Disabled Turbine Trip - Ngā Tamariki Power Station

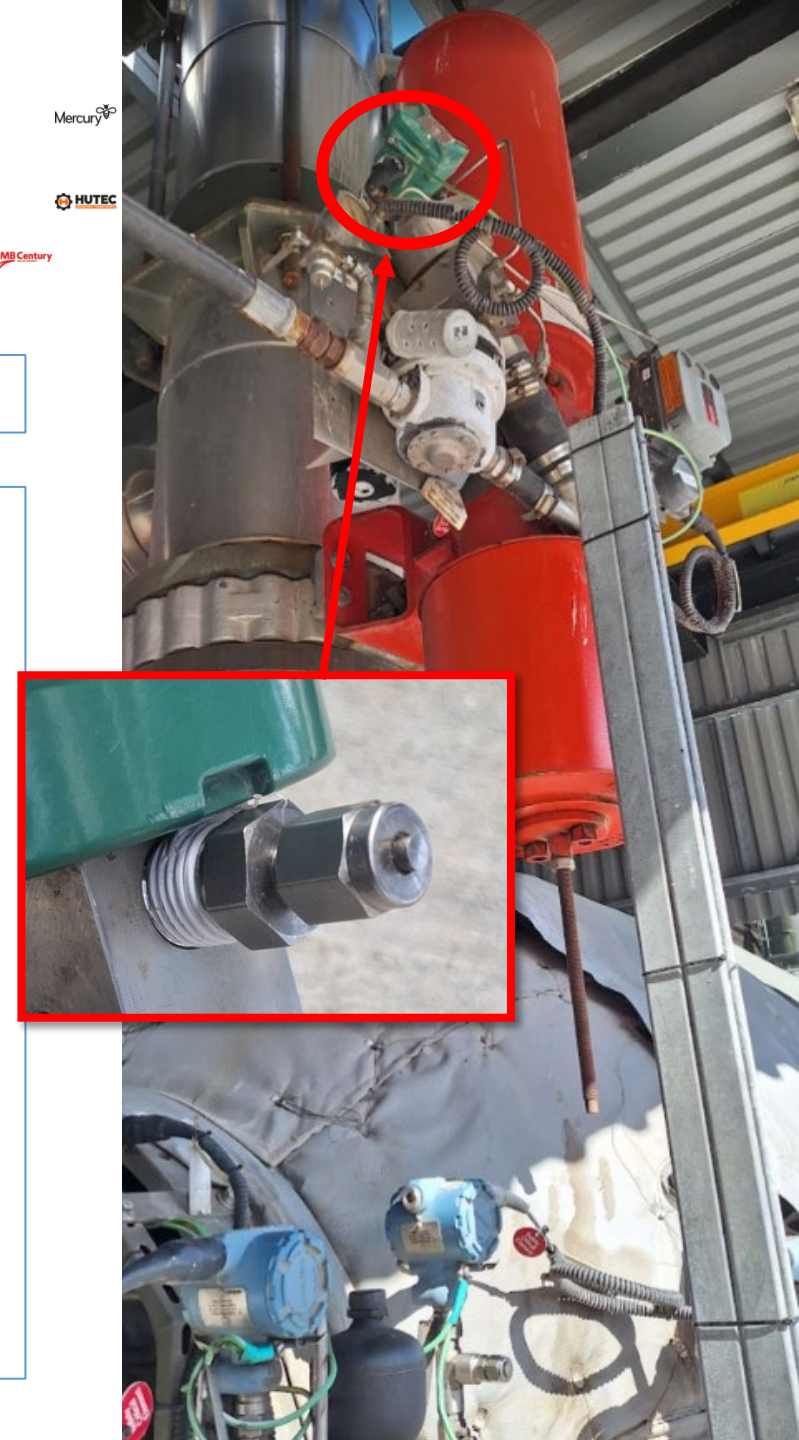
- During turbine valve trip testing, one of the turbine injection valves failed to close.
- Inspection revealed that the quick exhaust trip solenoid vent port had been intentionally plugged.
- The reason for the plug remains unknown; requiring tools and ladder access to disable this safety critical element (SCE).
- In any overspeed event or other critical turbine trip, this valve would have remained fully open, reducing protection from 1002 valves (stop valve or injection valve) to 1001.

- Reinforces the need for regular function/trip testing.
- Emphasizes the importance of thorough SCE inspections.
- Highlights the need for workers to understand the role of SCEs and be aware of any changes — no matter how minor.
