# Safety alert

## Electronic Trailer Brake Failure

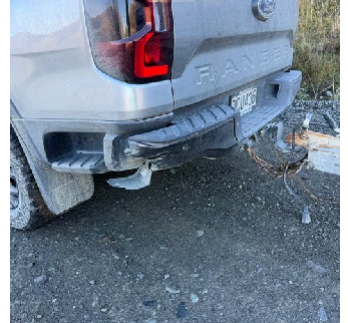
A loaded trailer was being transported between two locations on a gravel road. Prior to departure, pre-use checks were completed, including verification of the trailer lighting system. While descending a hill towards the powerhouse at low speed on a 30 km/h road and approaching a corner, the driver applied the brakes. The trailer failed to decelerate as expected, continued moving forward, and jackknifed. As a result, the towing vehicle left the roadway and came to rest in a swale drain.

Following the incident, the driver exited the vehicle and discovered that the trailer electrical plug had become disconnected from the vehicle socket, rendering the trailer brakes inoperative.

Trailer plugs can become disconnected under certain operating conditions. In this case, the travel route contained several ruts and included both uphill and downhill sections, which may have contributed to the plug disengaging.

- Verify trailer brake operation in a controlled environment before travel, such as on a straight section of road, including trailer plugs correctly connected.
- Adjust travel speed to suit road conditions and load weight, with additional caution when towing heavy loads.
- Ensure the trailer braking system is appropriate for the weight and nature of the load being transported.
- Consider reducing load size or completing multiple trips where practical to minimise the consequences of a control failure, such as loss of trailer braking capability.
